Allied Paper, Inc./ Portage Creek/  
Kalamazoo River Superfund Site

## Former Plainwell Impoundment 2010 Bank Conditions Monitoring Report

Georgia-Pacific LLC

April 2011

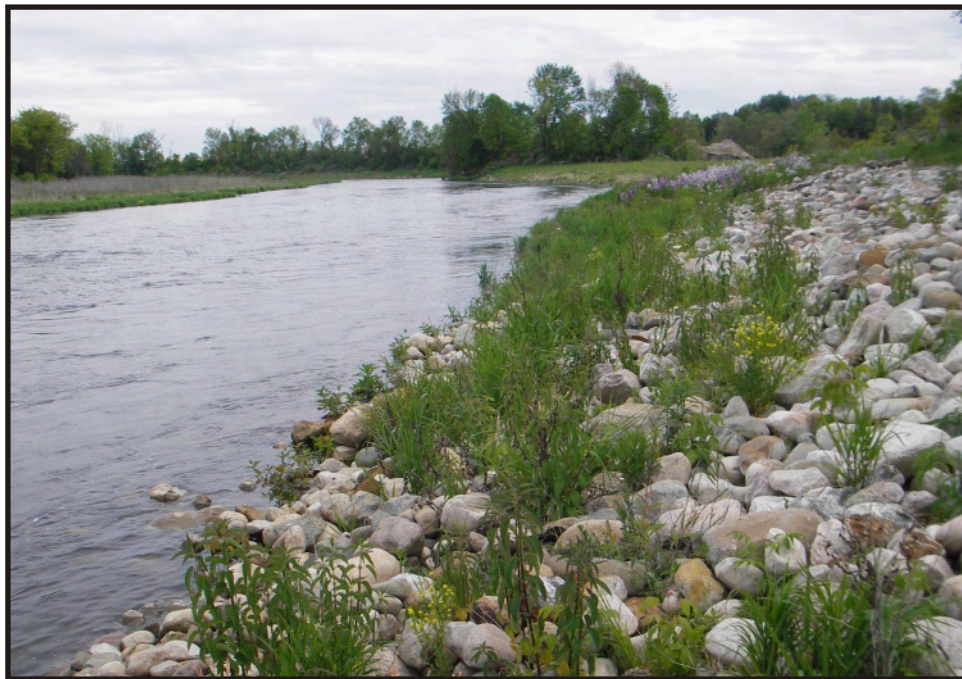
**32**

**Photo #32:** BEHI Area K1 (Low Erosion Potential) on south bank upstream of the former Plainwell Dam, looking southeast.

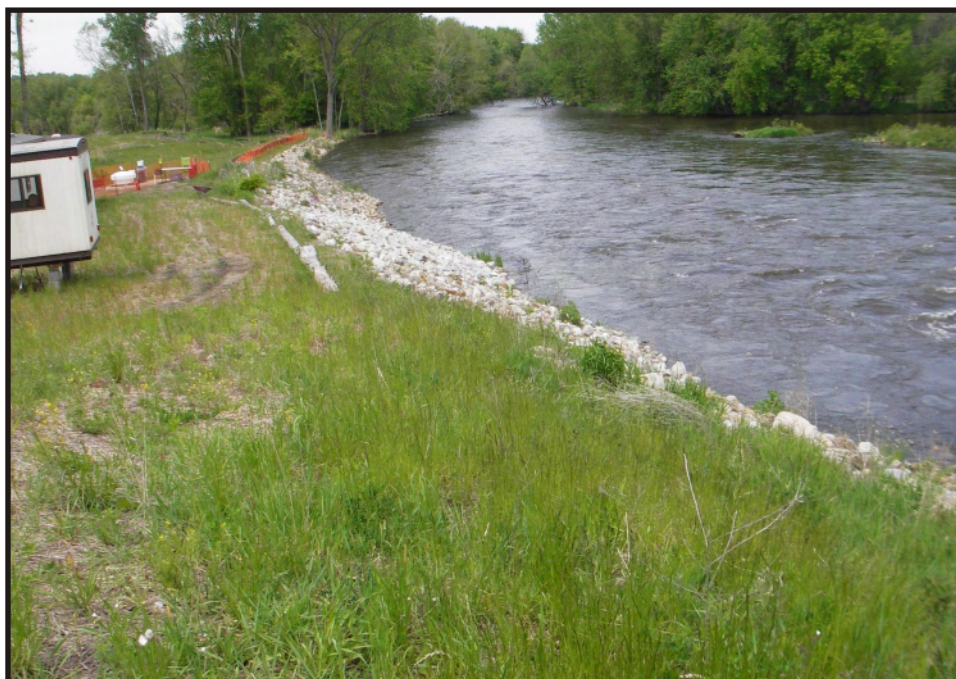
**33**

**Photo #33:** BEHI Area H (Very Low Erosion Potential) on south bank downstream of the former Plainwell Dam, looking northwest.

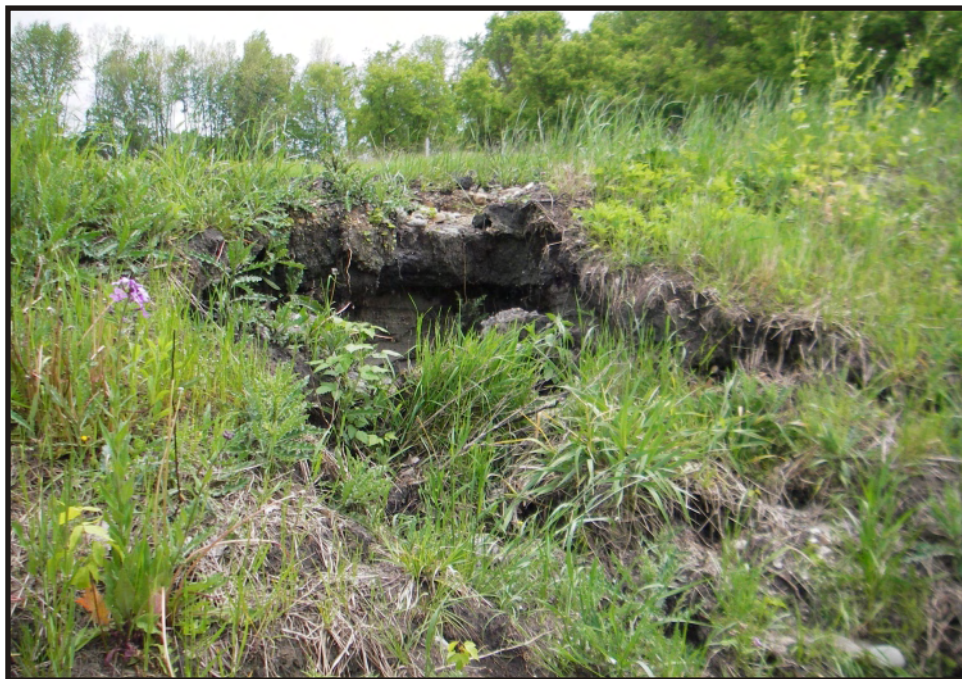
**35**

**Photo #35:** Collapsed top of south bank opposite former southern staging area.
